1	AIR LEAKAGE TESTING OF INDIVIDUAL SUITES IN MULTI-UNIT RESIDENTIAL BUILDINGS	2
1.1	INTRODUCTION.....	3
1.1.1	Scope.....	4
1.1.2	Background.....	5
1.1.2.1	Test Procedure and Issues.....	5

1 AIR LEAKAGE TESTING OF INDIVIDUAL SUITES IN MULTI-UNIT RESIDENTIAL BUILDINGS

Air leakage testing of six suites in four multi-unit residential buildings in Vancouver, BC was performed to quantify air leakage between adjacent suites, floors, common spaces and through the exterior building enclosure.

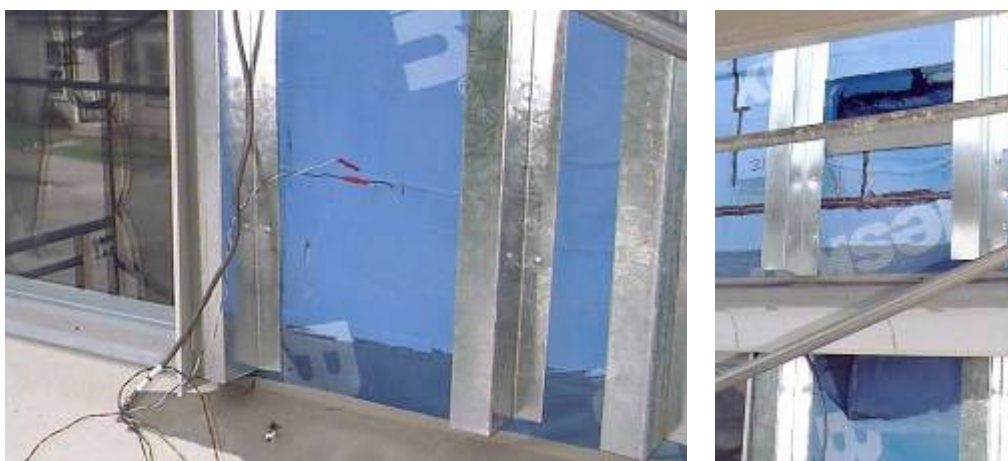
Figure 1-7: Building 3 – Air Barrier Membrane over Gypsum Sheathing

Moisture problems within the rehabilitated exterior walls of Building 3 were noted by Finch et al. (2006) and found to be correlated with humid interior conditions and condensation at the gypsum sheathing during the winter.

The source of make-up supply air to the suites was also questioned as several door undercuts were missing or blocked with weather-stripping.

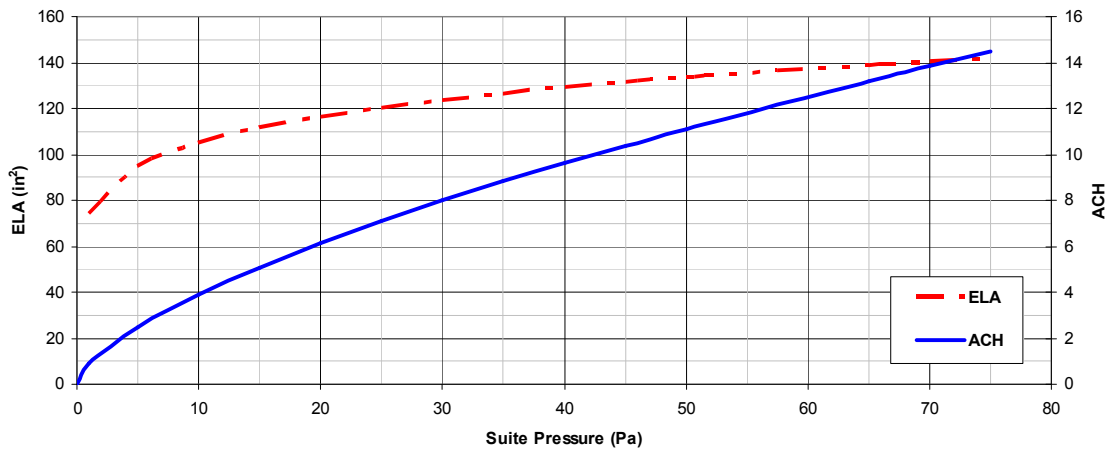
Figure 1-12: Exterior Wall ELA and ACH Relationships for Suite 401, Building 2

If a pressure coefficient of 0.65 is assumed, the 50 Pa measurements can be converted to a range of pressures more commonly seen in service (Figure 1-12).

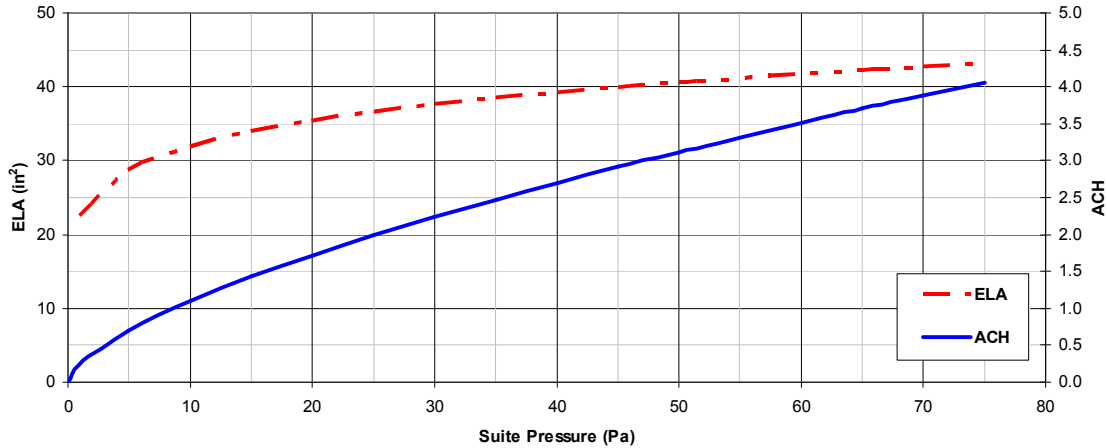
Figure 1-13: Exterior Wall ELA and ACH Relationships for Suite 608, Building 3

The impact of taping the bathroom and kitchen exhaust fan inlets was tested by performing a series of additional tests. At 50 Pa, when the bathroom duct inlet was sealed with plastic tape, the equivalent leakage area dropped by 26 cm², when both bathroom and kitchen ducts were sealed this dropped to 32 cm² from a total of 280 cm².

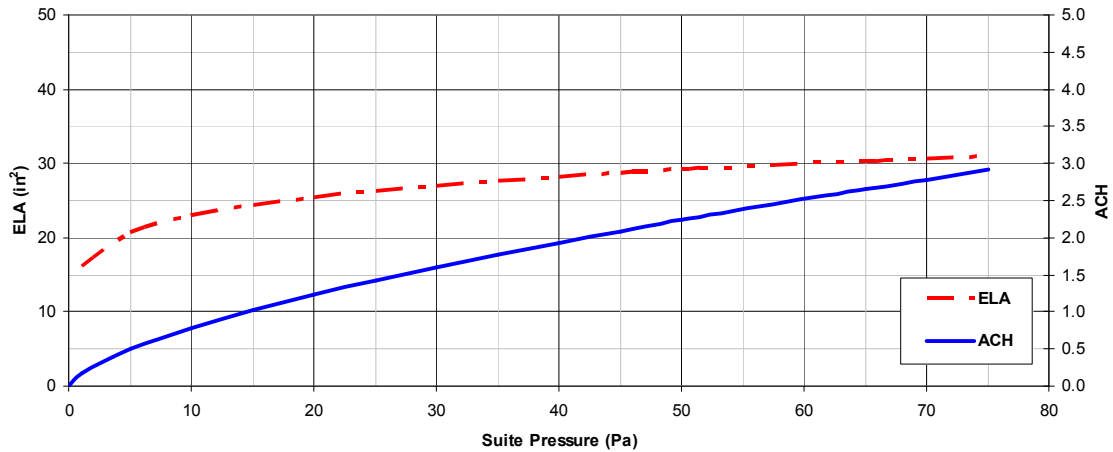
Figure 1-14: Exterior Wall ELA and ACH Relationships for Suite 611, Building 3

Like suite 608 the area of in-slab ducts make up approximately 50 cm² to 100 cm² of the exterior leakage area. The remainder of the leakage to the exterior is assumed to occur around windows, and penetrations through the building enclosure.

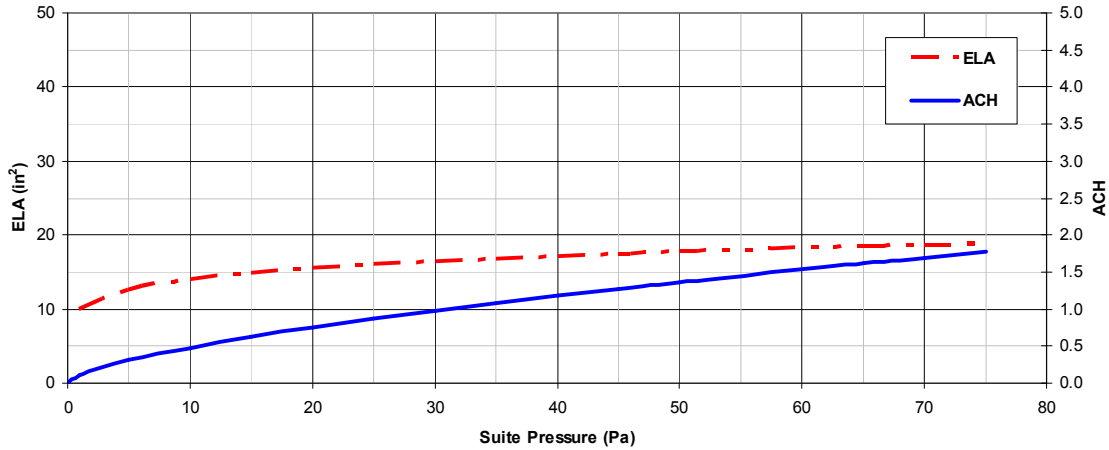
Figure 1-15: Exterior Wall ELA and ACH Relationships for Suite 311, Building 3

The impact of taping the bathroom and kitchen exhaust fan inlets were tested by performing a series of additional tests. At 50 Pa, when the bathroom duct inlet was sealed with plastic tape, the equivalent leakage area remained the same, indicating air was potentially bypassing the inlet grille, possibly at other penetrations in the wall or ceiling.

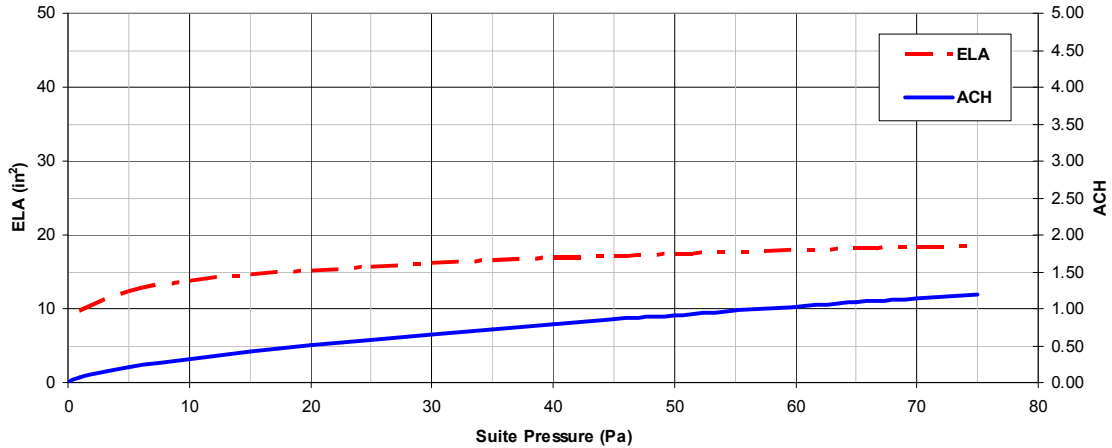
Figure 1-16: Exterior Wall ELA and ACH Relationships for Suite 802, Building A

The impact of taping the bathroom and kitchen exhaust fan inlets was tested by performing a series of additional tests. At 50 Pa, when the bathroom duct inlet was sealed with plastic tape, the equivalent leakage area dropped by 18 cm², when both bathroom and kitchen ducts were sealed this total dropped to 29 cm² from a total exterior enclosure leakage of 115 cm².

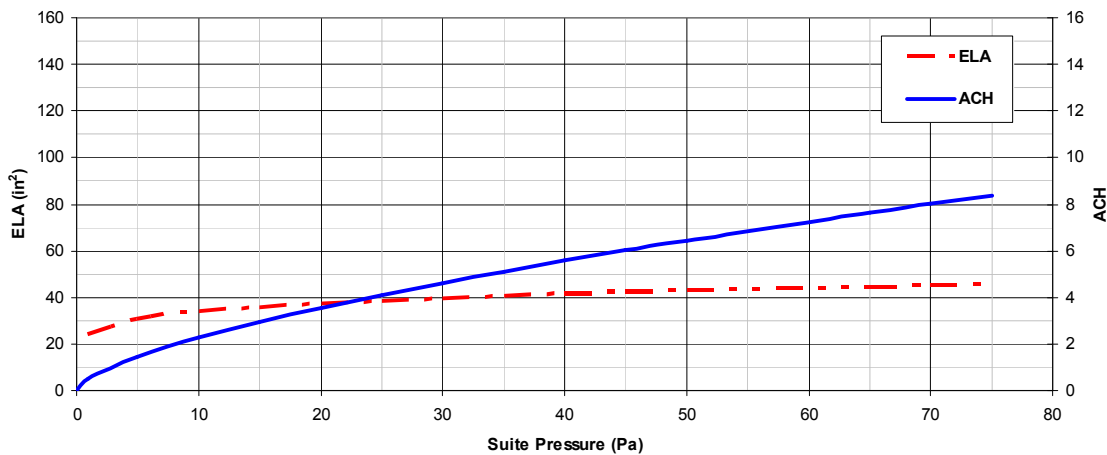
Figure 1-17: Exterior Wall ELA and ACH Relationships for Suite 309, Building 4

The impact of taping the bathroom and kitchen exhaust fan inlets was tested by performing a series of additional tests. At 50 Pa, when the bathroom duct inlet was sealed with plastic tape, the equivalent leakage remained the same. Sealing the bathroom/kitchen fans may also only have a minimal impact, as air may be drawn from other openings (electrical outlets) which are attached to the pressurized plenum created by the fan.

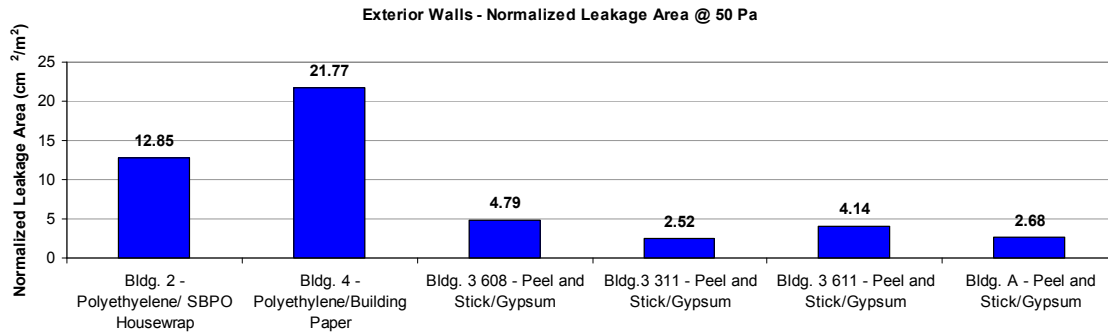
Figure 1-18: Comparison of Normalized Air Leakage through Exterior Walls

Here the two wood-frame exterior walls had the highest normalized leakage area, consistently higher than the steel stud and gypsum walls with the peel and stick air barrier. Suites 608 and 611 at the top floor of Building 3 had higher leakage areas than the other two of this set as likely some air leakage through the roof was measured but could not be isolated from the results.

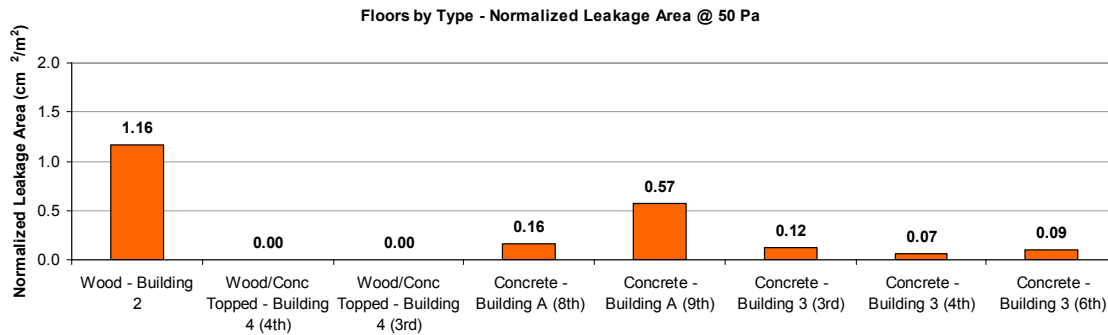
Figure 1-19: Comparison of Normalized Air Leakage through Floors by Type

The tightest system was the concrete topped wood frame wall followed by the concrete slab floor. The wood frame floor had the highest air leakage. The air leakage through a floor slab depends largely on how well the penetrations were fire/smoke sealed. It appears in Building A, one or several of the penetrations were poorly sealed, contributing to the higher than average leakage through this solid concrete slab. The wood frame floor as could be expected had a higher

leakage area, due to penetrations, gaps, or shrinkage of the plywood and wood joist floor.

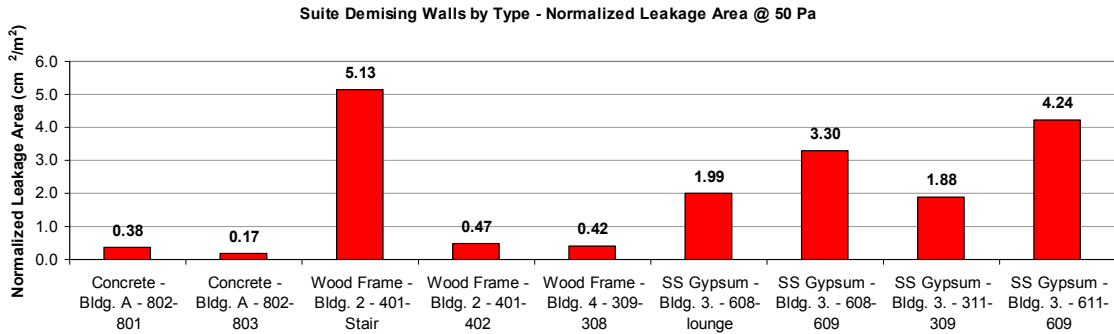
Figure 1-20: Comparison of Normalized Air Leakage through Demising Walls

The solid concrete walls were the tightest, followed by the wood frame walls (with exception of one location), and finally the steel-stud and gypsum demising walls. The differences between solid concrete and the framed walls are obvious, however it appears that wood-framed walls were constructed tighter than steel-stud and gypsum framed walls.

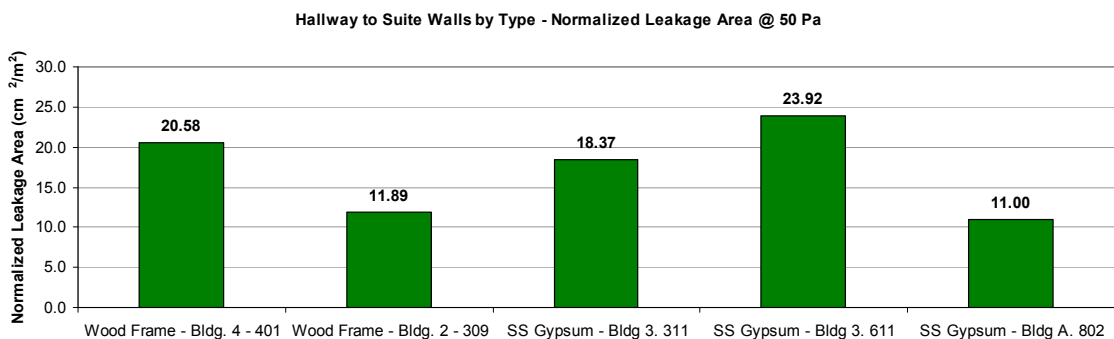
Figure 1-21: Comparison of Normalized Air Leakage through Hallway Walls

Air leakage through the hallway door is excluded from these tests, which has a leakage area is in the order of 50 cm²/m² for a standard entrance door with a 1 cm door undercut normalized over the total area of the door frame. Therefore the

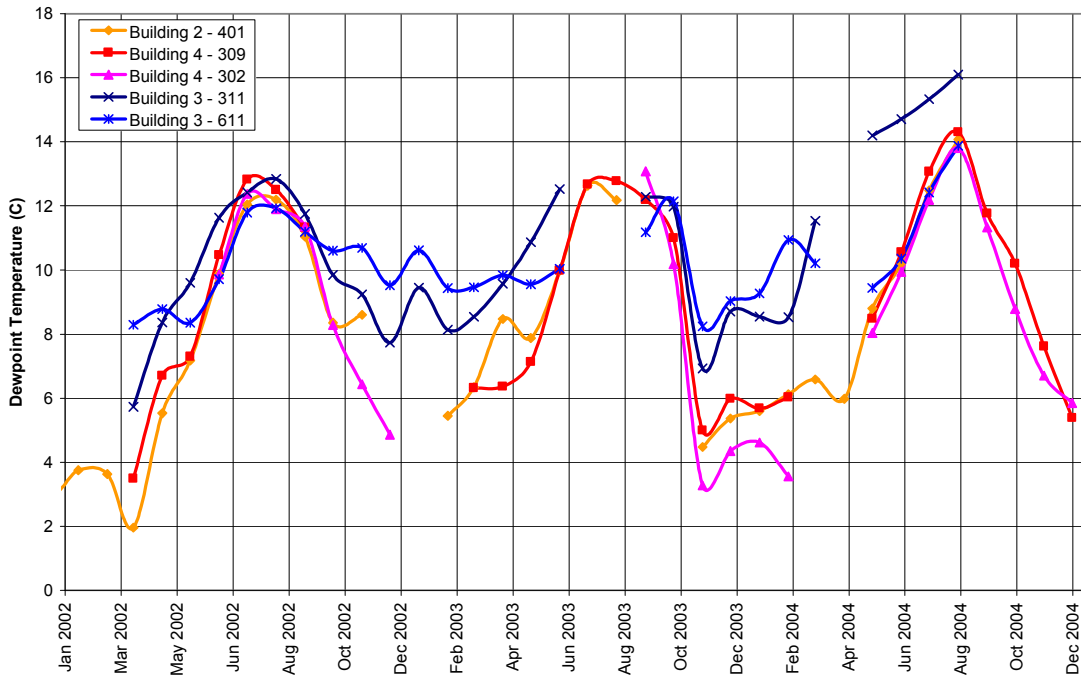
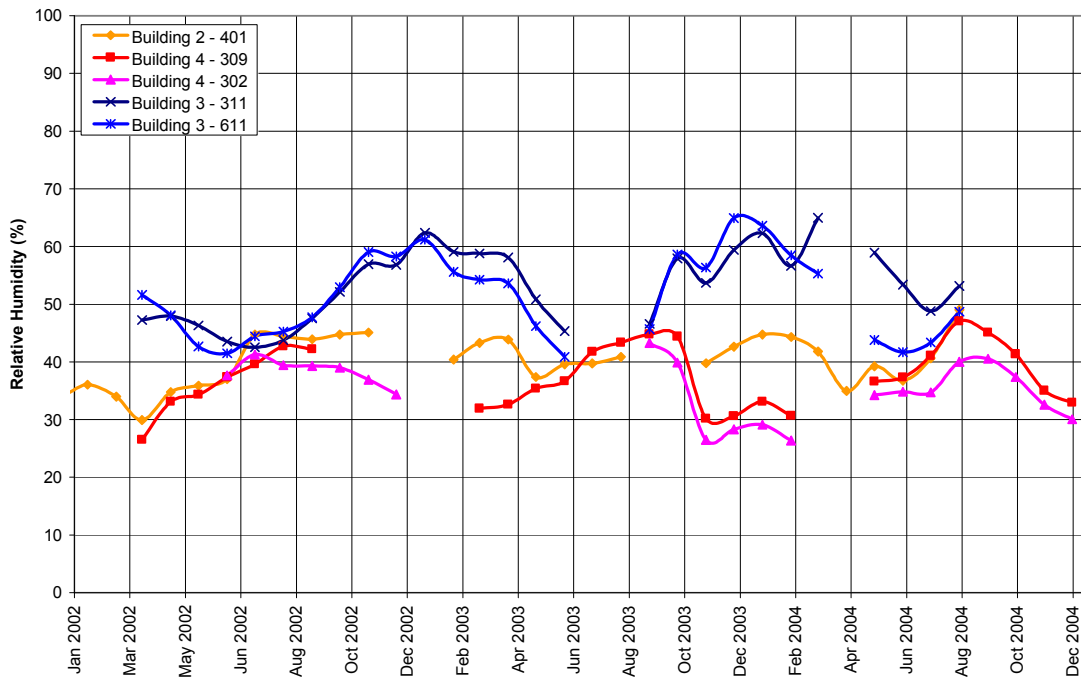
The interior dewpoint and relative humidity within suites of Buildings 2 and 4 remain relatively close over the three years, showing similar seasonal trends which are average for Vancouver. Building 2 is slightly more humid than Building 4, however the occupant in Building 2 uses a humidifier during the winter and has a number of large plants which would increase wintertime humidity.
