1	AIR LEAKAGE TESTING OF INDIVIDUAL SUITES IN MULTI-UNIT RESIDENTIAL BUILDINGS	2
1.1	INTRODUCTION.....	3
1.1.1	Scope.....	4
1.1.2	Background.....	5
1.1.2.1	Test Procedure and Issues.....	5

1 AIR LEAKAGE TESTING OF INDIVIDUAL SUITES IN MULTI-UNIT RESIDENTIAL BUILDINGS

Air leakage testing of six suites in four multi-unit residential buildings in Vancouver, BC was performed to quantify air leakage between adjacent suites, floors, common spaces and through the exterior building enclosure.

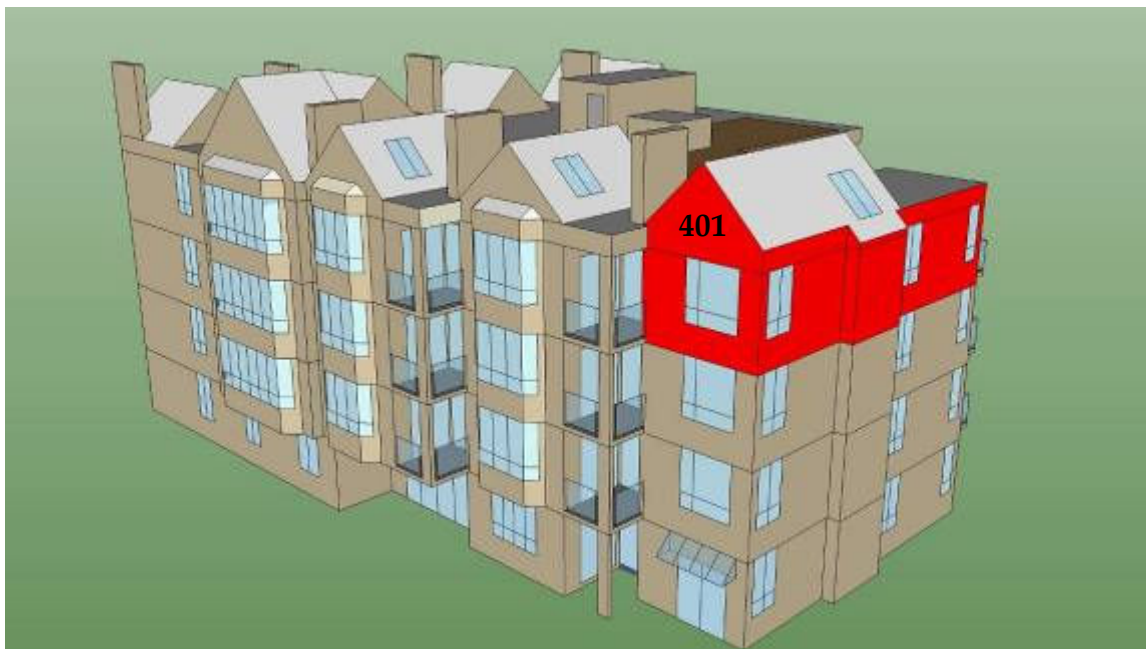
Figure 1-4: Building 2 – Suite 401 Highlighted at Southeast Corner

It is shown that a relatively large percentage of the air leakage through this suite is through the exterior walls, roof, and exhaust ducts. The suite demising walls and floors are relatively well sealed. A high percentage of the interior air leakage is through the hallway through unintentional openings, potentially through the attic/cathedral ceiling space of this suite. Several penetrations through the gypsum drywall which are typically unsealed were observed in the hallway (sprinkler heads, lights, switches, receptacles etc.).

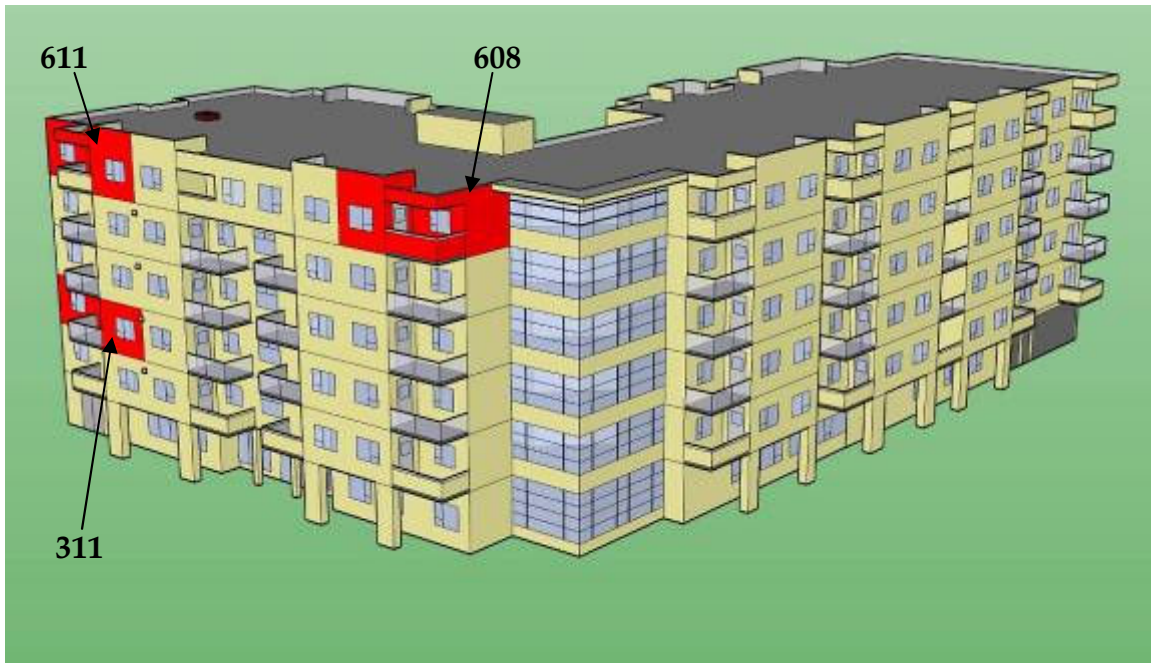
Figure 1-8: Building 3 – Suites 311, 611 and 608 Highlighted.

Moisture problems within the rehabilitated exterior walls of Building 3 were noted by Finch et al. (2006) and found to be correlated with humid interior conditions and condensation at the gypsum sheathing during the winter.

Further monitoring and testing by Roppel et al. (2007) determined ventilation rates by measuring exhaust fan flow and CO₂ levels within several suites and found that the low ventilation levels were contributing to the high interior humidity levels.

The source of make-up supply air to the suites was also questioned as several door undercuts were missing or blocked with weather-stripping.

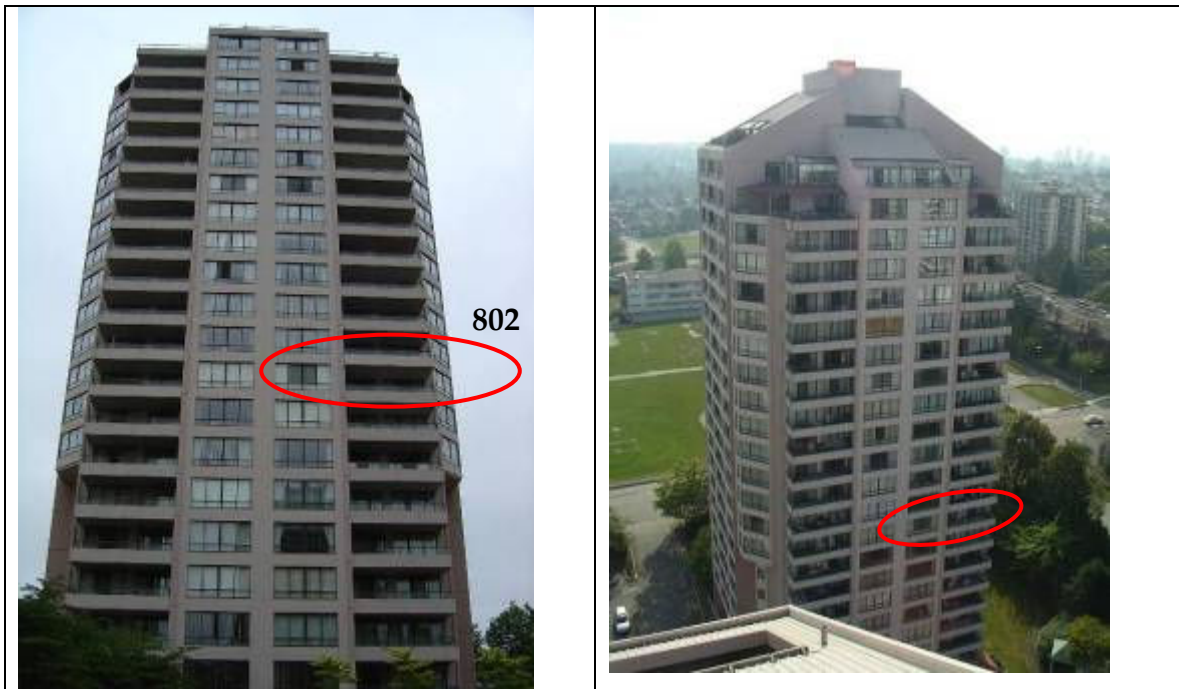
Figure 1-11: Building A – Overview of South Elevation

Suite 802 in the building was chosen for air leakage testing as the occupant had complained of high humidity and condensation on the windows during the winter months. It was suspected that insufficient ventilation was occurring in this suite (and others) in this recently rehabilitated building. The air leakage testing was performed to determine the source of the makeup air, and the air tightness of the exterior building enclosure which had recently been rehabilitated.

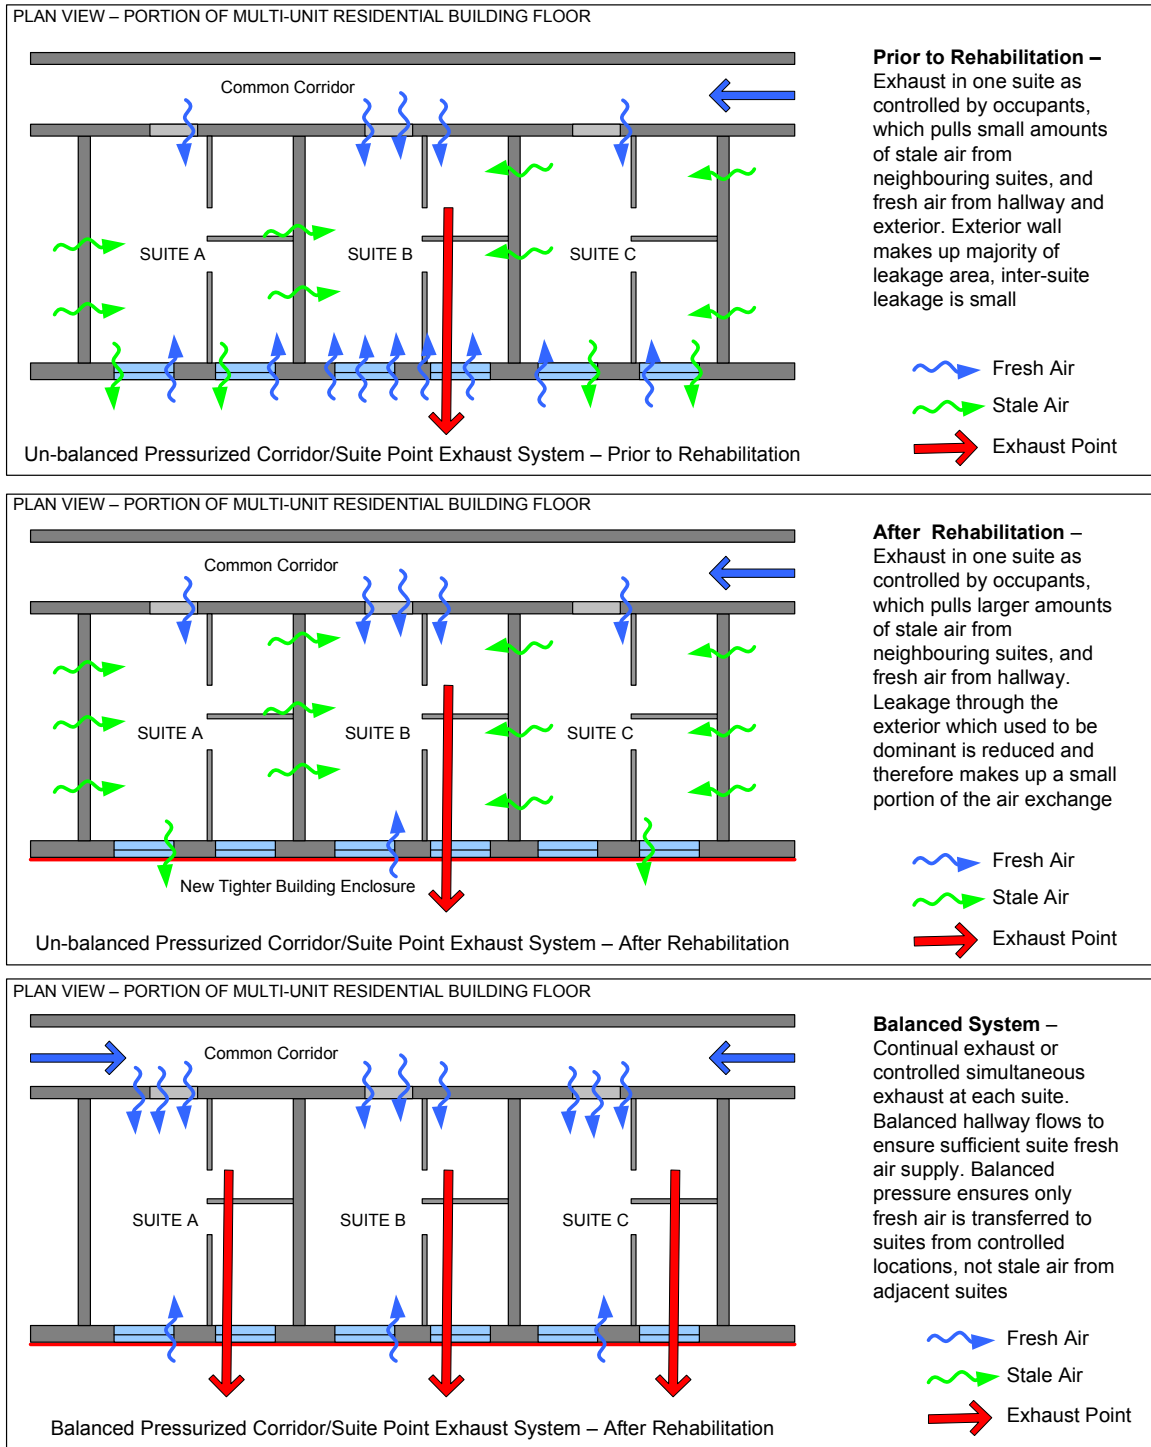
Figure 1-24: Impact of Air Tightness of Walls on Mechanical Systems

Mechanical systems must be designed for each individual building and assumptions as to base air leakage rates through the building enclosure are no longer valid with modern wall assemblies.

Figure 1-24 graphically shows the impact of air tightening the exterior wall of a building (such as during a rehabilitation) on suite ventilation and how problems could be avoided by using a balanced system, with continual or controlled exhaust in each suite, while ensuring sufficient makeup air reaches each suite.
